Article

An Assessment of the Microbiological Water Quality of Sand Dams in Southeastern Kenya

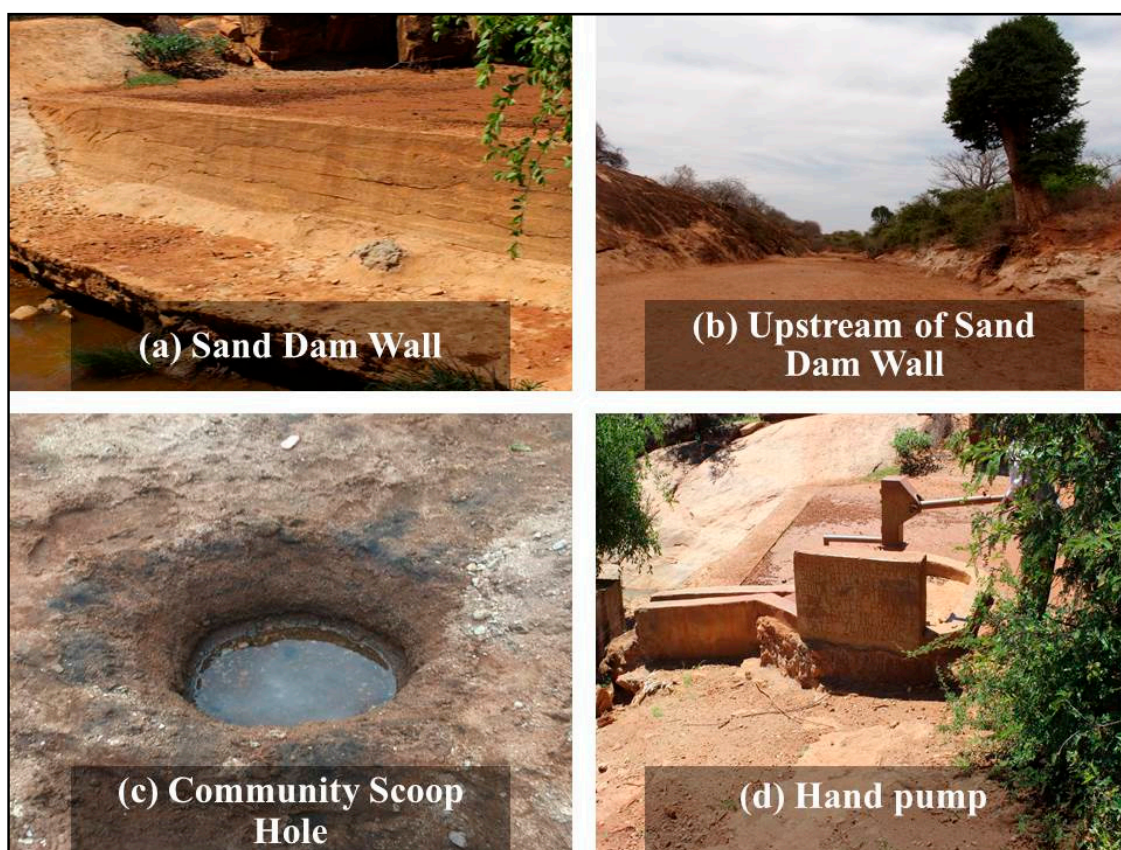
Figure 1. The sand dams and their water abstraction methods.

Thus, the aim of this research was to assess both the microbiological safety of water contained in the dam (through test holes) and the safety of water abstracted by the local population (through scoop holes (Figure 1c) and covered wells (Figure 1d)).
